Certified Professional Inspector

Inspection Address - **Sample Report**
Date - **2015**
Client - **Confidential**
Phone -
Email Address -

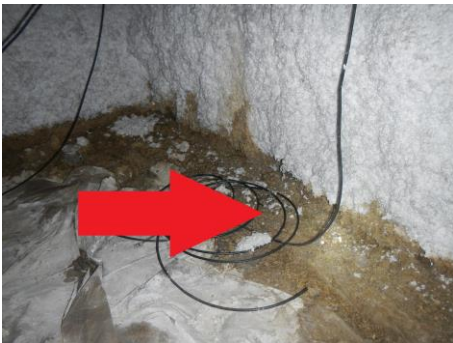
- Moisture intrusion (seeping) in rear crawl space. Suspected causes include negative slope and depressions in grade at foundation on right side and inadequate downspout location.
- Moderate stress cracking in basement floor.
- Deteriorated/damaged concrete at overhead garage door.

Water intrusion in rear crawl space.

- Fill all areas of low grade at the foundation and re-route or extend the affected downspout to provide adequate rainwater dispersion away from the foundation.
- Fill the cracks in the basement floor and deteriorated section of concrete in the garage with an appropriate sealant and monitor for re-occurrence or worsening conditions.

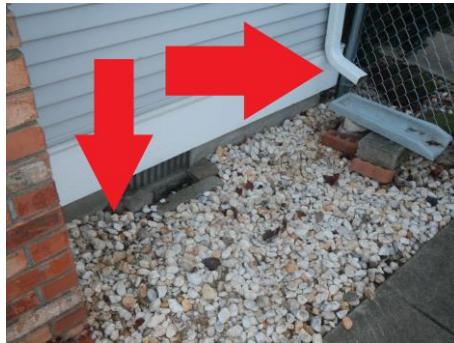
Improper grade and downspout.

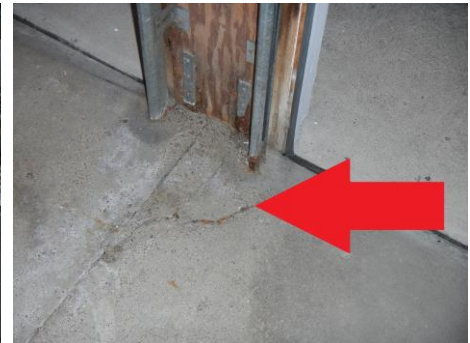
Damaged garage floor.

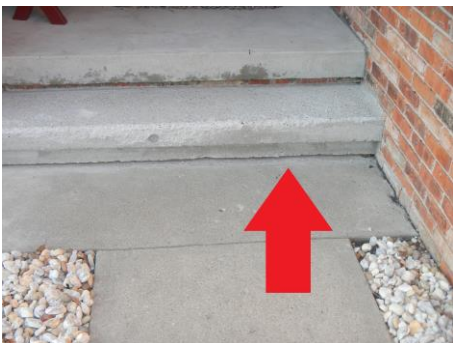
Concerns – Settled/shifted side walk slabs at front entry and right side of driveway.

Settled concrete walkway.

Recommendations – Re-level or replace the affected walkway slabs.

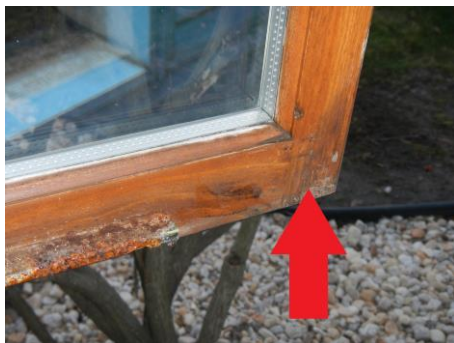
- Wood rot at lower corner of two dining room windows.
- Missing window cranks at several windows prevented testing/inspection.
- Minor worn weather strip at front entry door.
- Missing safety eye sensors at garage doors.

Damaged dining room windows.

- Repair or replace the affected dining room windows.
- Install cranks where missing and test/inspect all windows for damage.
- Replace the entry door weather strip.
- Install safety sensors at the garage doors or replace the openers with modern units.

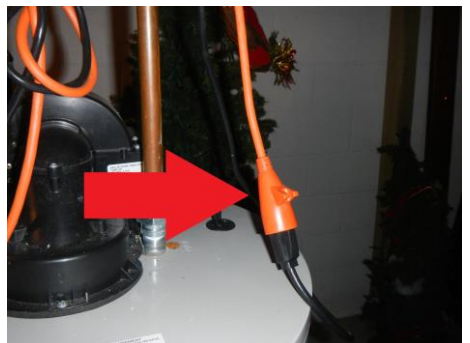
Concerns – Extension cord in use at water heater.

Missing outlet at water heater.

Recommendations – Install a dedicated receptacle near the water heater.
