ALL SAFE INSPECTIONS

RESIDENTIAL INSPECTION REPORT

930 Askin Street
Maumee, OH 43537

Stanley Jechura
01/30/2024

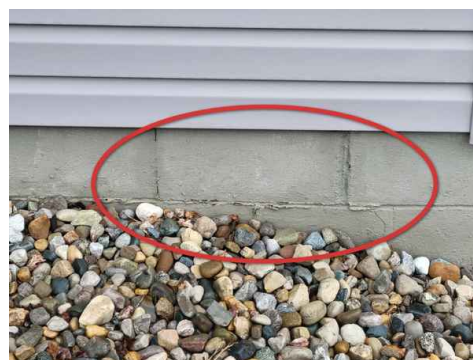
2.2.1 Exterior Walls

DETERIORATED MORTAR JOINTS

Deteriorating mortar joints can lead to loose blocks or brickwork and settling.

- Fill (tuck point) any deteriorated mortar joints to prevent worsening.

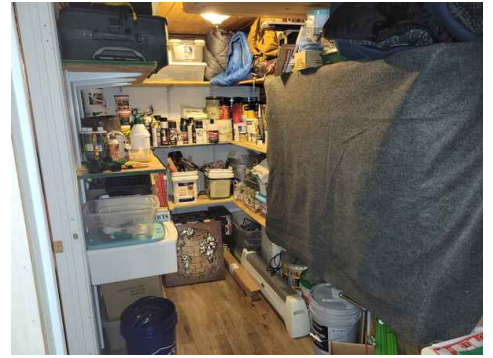
2.3.1 Basement

OBSTRUCTED

Portions of the basement were obstructed or inaccessible preventing adequate view.

- Further evaluation when accessible.

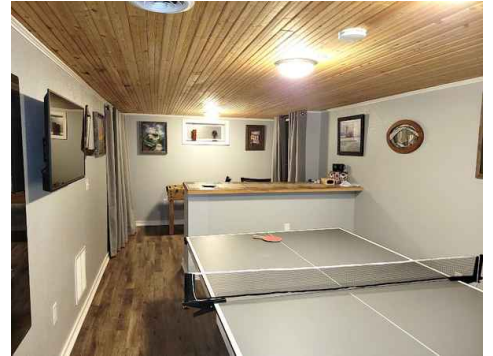
2.3.2 Basement

FINISHED AREA(S)

Portions or all of the basement walls were covered with finished materials preventing view/evaluation of foundation walls.

-Monitor the finished areas for signs of moisture.

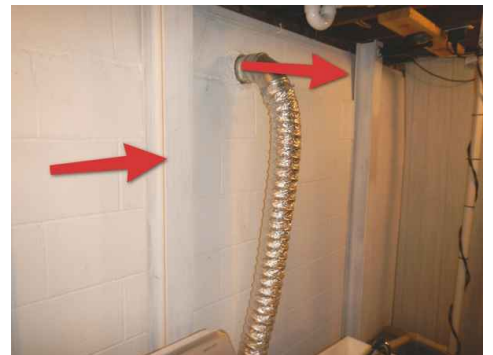
2.3.4 Basement

LEANING OR BOWING - REPAIRED

Repaired or re-supported walls indicate past significant foundation damage or movement concerns.

- Monitor for worsening.

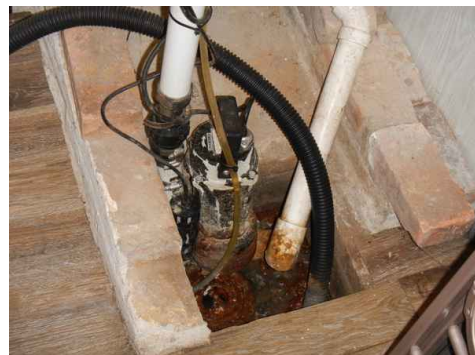
2.3.5 Basement

Maintenance or Low Priority**SUMP PUMP OR CROCK - IMPROPER INSTALLATION**

Improperly installed or temporary/emergency use type installation indicates possible possible past water intrusion concerns.

- Properly install the sump pump.

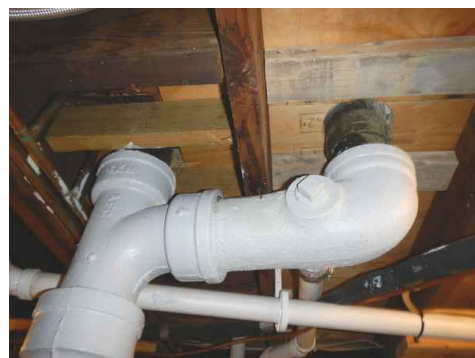
2.4.1 Framing

Maintenance or Low Priority**VISIBLE PREVIOUS REPAIRS - ACCEPTABLE**

Previously repaired or re-supported flooring indicates possible past damage or structural modification.

- Monitor or further evaluate the affected area(s).

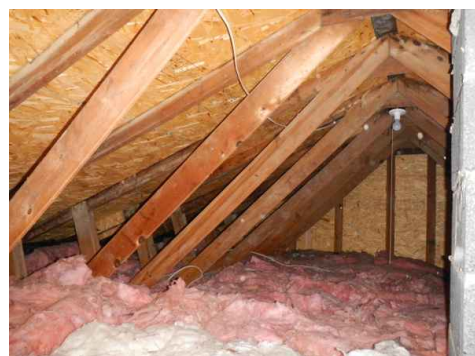
2.5.1 Attic(s)

Repairs Needed/Medium Priority**LIMITED ACCESS**

The attic was viewed from the access hatch only due to obstructions, lack of flooring, or location/size of opening.

- Further evaluation when accessible.

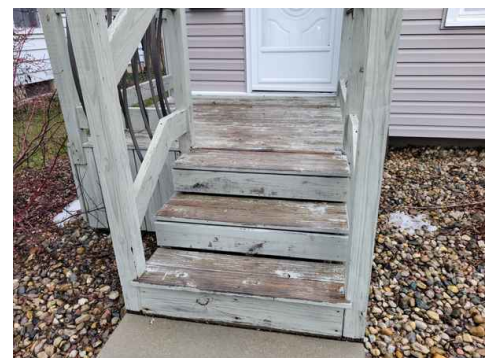
4.2.1 Decks, Balconies, & Porches

WORN/PEELING PAINT

FRONT ENTRY

Worn/peeling paint poses weathering concerns and a possible lead health hazard in homes built prior to 1978.

- Repaint as needed.

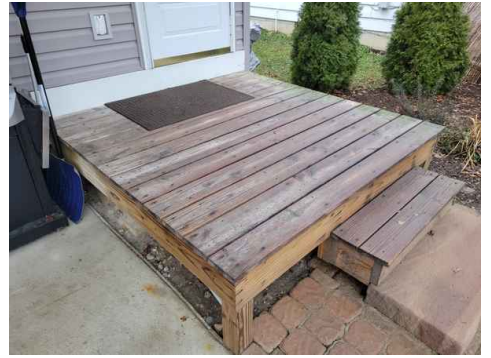
4.2.2 Decks, Balconies, & Porches

Repairs Needed/Medium Priority
EXPOSED WOOD

REAR ENTRY

Exposed wood poses excessive weathering and possible water damage concerns.

- Seal any exposed wood surfaces to prevent excessive weathering.

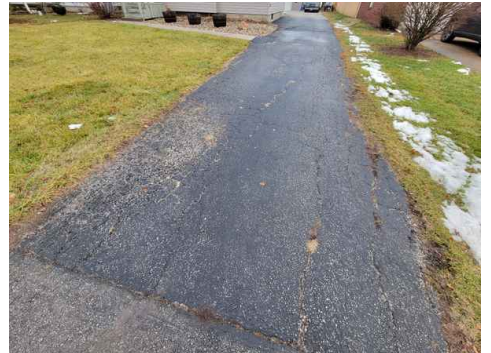
4.3.1 Walkways, Patios & Driveways

Repairs Needed/Medium Priority
ASPHALT - MODERATE TO SEVERE DAMAGE

DRIVEWAY

Moderate to severe cracking, settling, or deterioration was observed.

- Fill any cracks/repair and re-seal as needed or consider replacement based on severity of concerns.

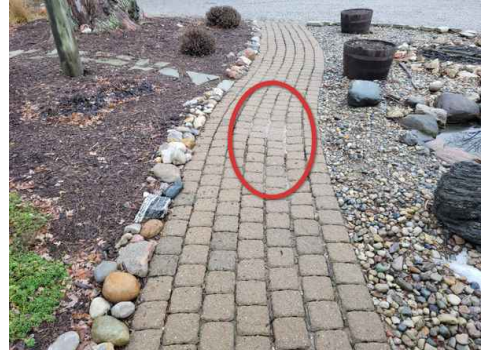
4.3.2 Walkways, Patios & Driveways

Repairs Needed/Medium Priority
PAVERS - SETTLED, UNEVEN, OR DAMAGED

REAR WALKWAY

Settled or damaged pavers can pose a possible trip/fall safety hazard.

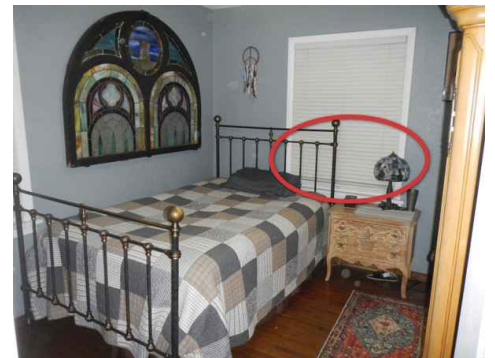
5.1.1 Windows

OBSTRUCTED

FRONT BEDROOM

One or more windows or doors were obstructed preventing full view/evaluation or testing.

- Further evaluation/testing when accessible.

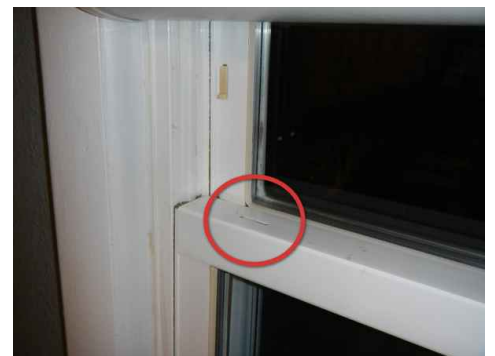
5.1.2 Windows

HARDWARE - DAMAGED OR MISSING

ALL WINDOWS

Missing tilt latch covers do not affect operation of windows.

Damaged or missing hardware such as lock latches, tilt latches, or cranks and operating mechanisms were observed preventing proper operation.

- Replace any damaged or missing hardware.

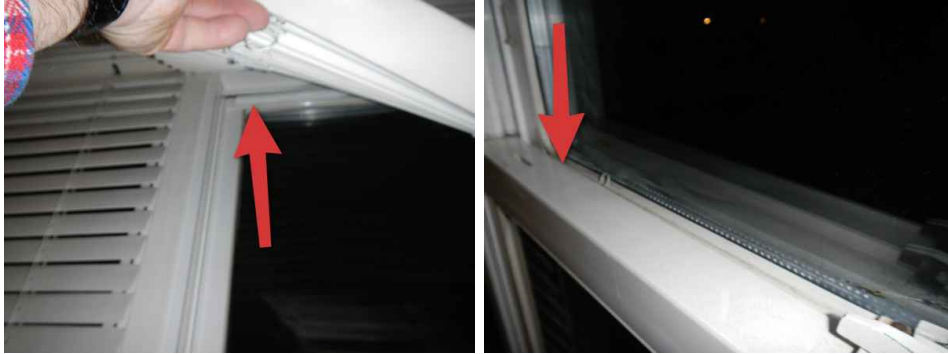
5.1.3 Windows

INOPERABLE OR STUCK SASHES

LIVING ROOM - FRONT RIGHT WINDOW

One or more windows were inoperable, painted shut, or **stuck partially open** preventing proper operation.

- Further evaluate and repair to functional use.

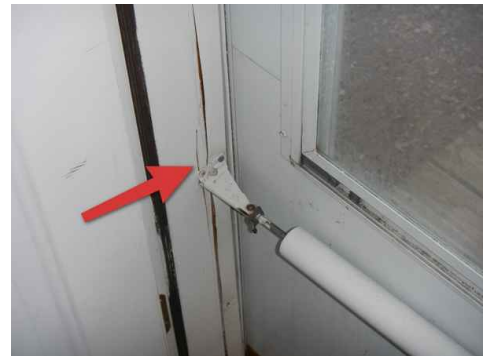
5.2.1 Doors

DAMAGED OR RUSTED

REAR ENTRY DOOR

Cracked jamb at closer.

Damaged or rusted doors were observed.

- Repair or replace any affected doors as deemed appropriate.

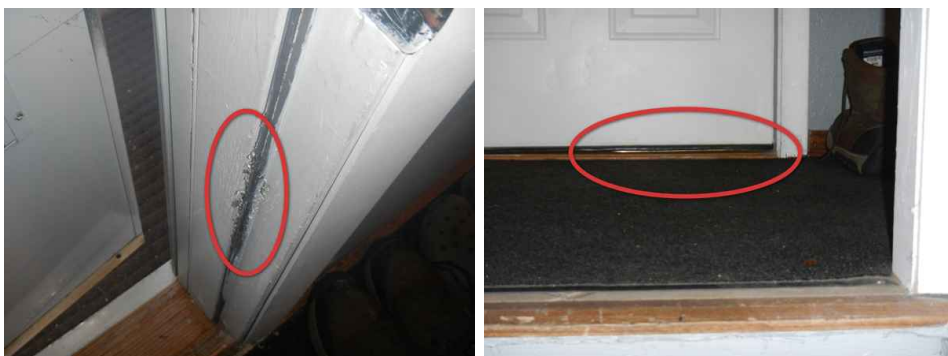
5.2.2 Doors

WEATHERSTRIPPING - DAMAGED OR MISSING

REAR ENTRY DOOR

Missing, inadequate or deteriorated weatherstrip poses excessive draft and energy loss concerns.

- Replace any missing or worn weatherstrip to prevent energy loss.

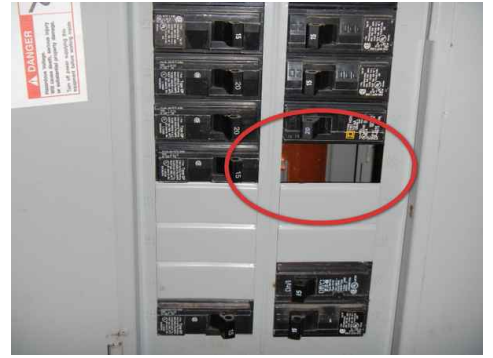
8.2.1 Service Panels

MISSING BREAKER SLOT COVER(S)

MAIN PANEL

Missing breaker slot covers pose a possible safety hazard.

- Replace any missing breaker slot covers.

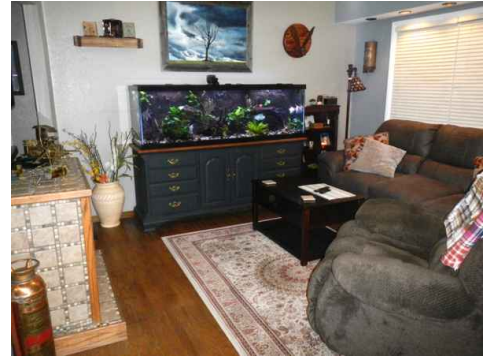
8.3.1 Outlets, Switches & Fixtures

OBSTRUCTED

LIVING ROOM AND BEDROOMS

Multiple outlets were obstructed or in use preventing testing.

- Further evaluation and testing when accessible.

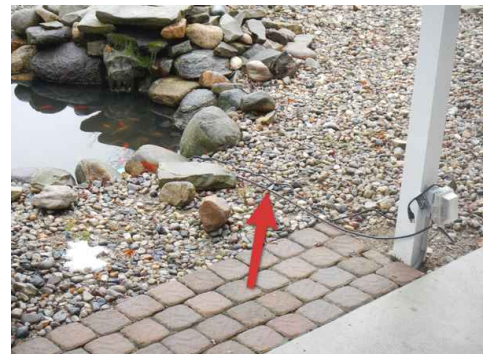
8.3.2 Outlets, Switches & Fixtures

EXTENSION CORD IN PERMANENT USE

REAR PATIO/POND

Extension cords pose a potential electrical safety hazard.

- Install appropriately located outlets.

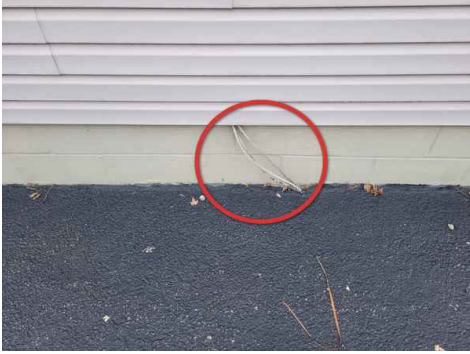
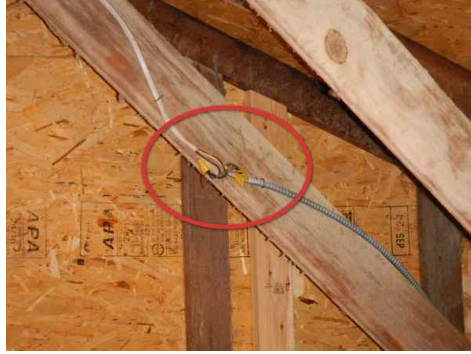
8.3.3 Outlets, Switches & Fixtures

EXPOSED WIRING AND/OR CONNECTIONS

ATTIC AND DRIVEWAY

Exposed wiring or connections pose a potential electrical safety hazard.

- Install junction boxes at any exposed wiring connections or conduit at any exposed wiring.

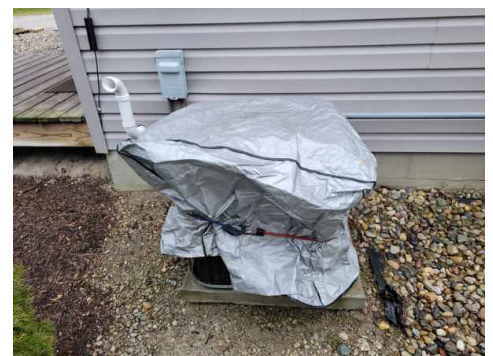
9.2.1 Cooling

LOW OUTSIDE AIR TEMPERATURE

Unit was winterized/covered.

Unable to test unit due to low outside air temperature (less than 60 degrees) at the time of inspection.

- Further evaluation/testing when weather conditions permit.

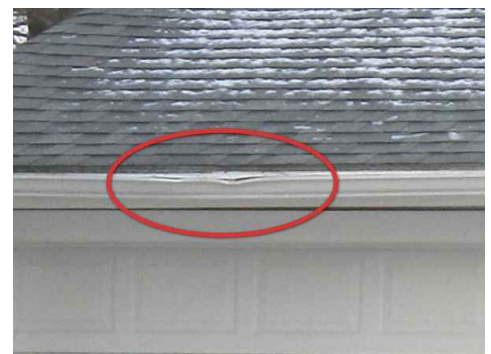
11.4.1 Gutter System and Grading

GUTTERS - DAMAGED, MISSING, OR INADEQUATE

Dented front gutter does not affect operation.

Damaged, missing, or inadequate gutters pose foundation water intrusion and movement concerns or hidden damage such as rotted fascia boards and water intrusion in walls.

- Repair or replace the guttering as needed to ensure adequate rainwater dispersion away from the foundation and dwelling.

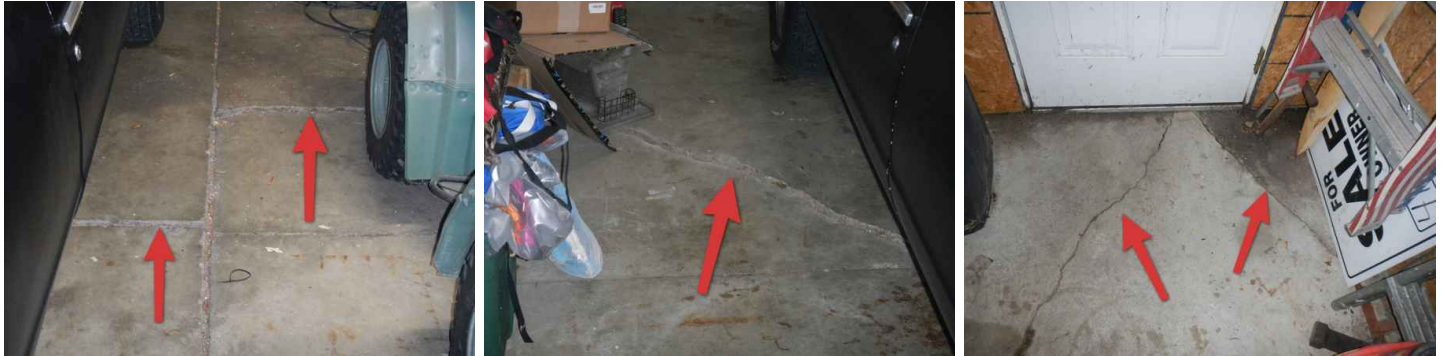
11.5.1 Floor Slab

CRACKED OR SHIFTED FLOOR SLAB

Cracks in the floor slab are typical and do not generally affect the structural integrity of the foundation.

Larger cracks or settling indicates past or possible excessive foundation movement due to oversaturated exterior grading.

- Fill any cracks with an appropriate sealant and monitor for re-occurrence or worsening.
- Correct any guttering or exterior grading concerns.
- Consult a qualified contractor for further evaluation and repair of larger cracks or excessive settling.

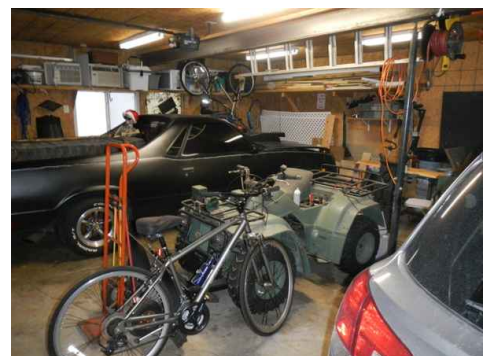
11.7.1 Framing

OBSTRUCTED OR LIMITED VIEW

All or portions of the framing were covered or obstructed preventing full view or evaluation.

- Further evaluation when accessible.

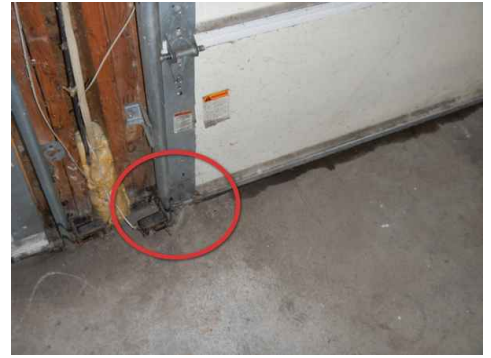
11.8.1 Doors and Windows

**AUTO REVERSE SENSOR -
FAULTY OR MISSING**

LEFT OVERHEAD DOOR.

The auto reverse safety sensors were missing or not operating properly when tested.

- Further evaluation and and repair.

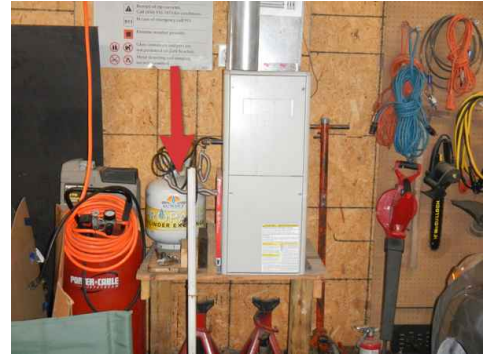
11.9.1 Heating System

INADEQUATE CLEARANCE**Propane tank next to furnace.**

Combustible materials were noted in close proximity to the fireplace posing a possible fire safety hazard.
